CITY OF PORT ALBERNI

SOMASS DEMOLITION – PLANER MILL - BUILDING # 8

REQUEST FOR PROPOSALS # 026-23

E0400-879 Hazmat Report – Somass Sawmill – Planer Mill - Building 8

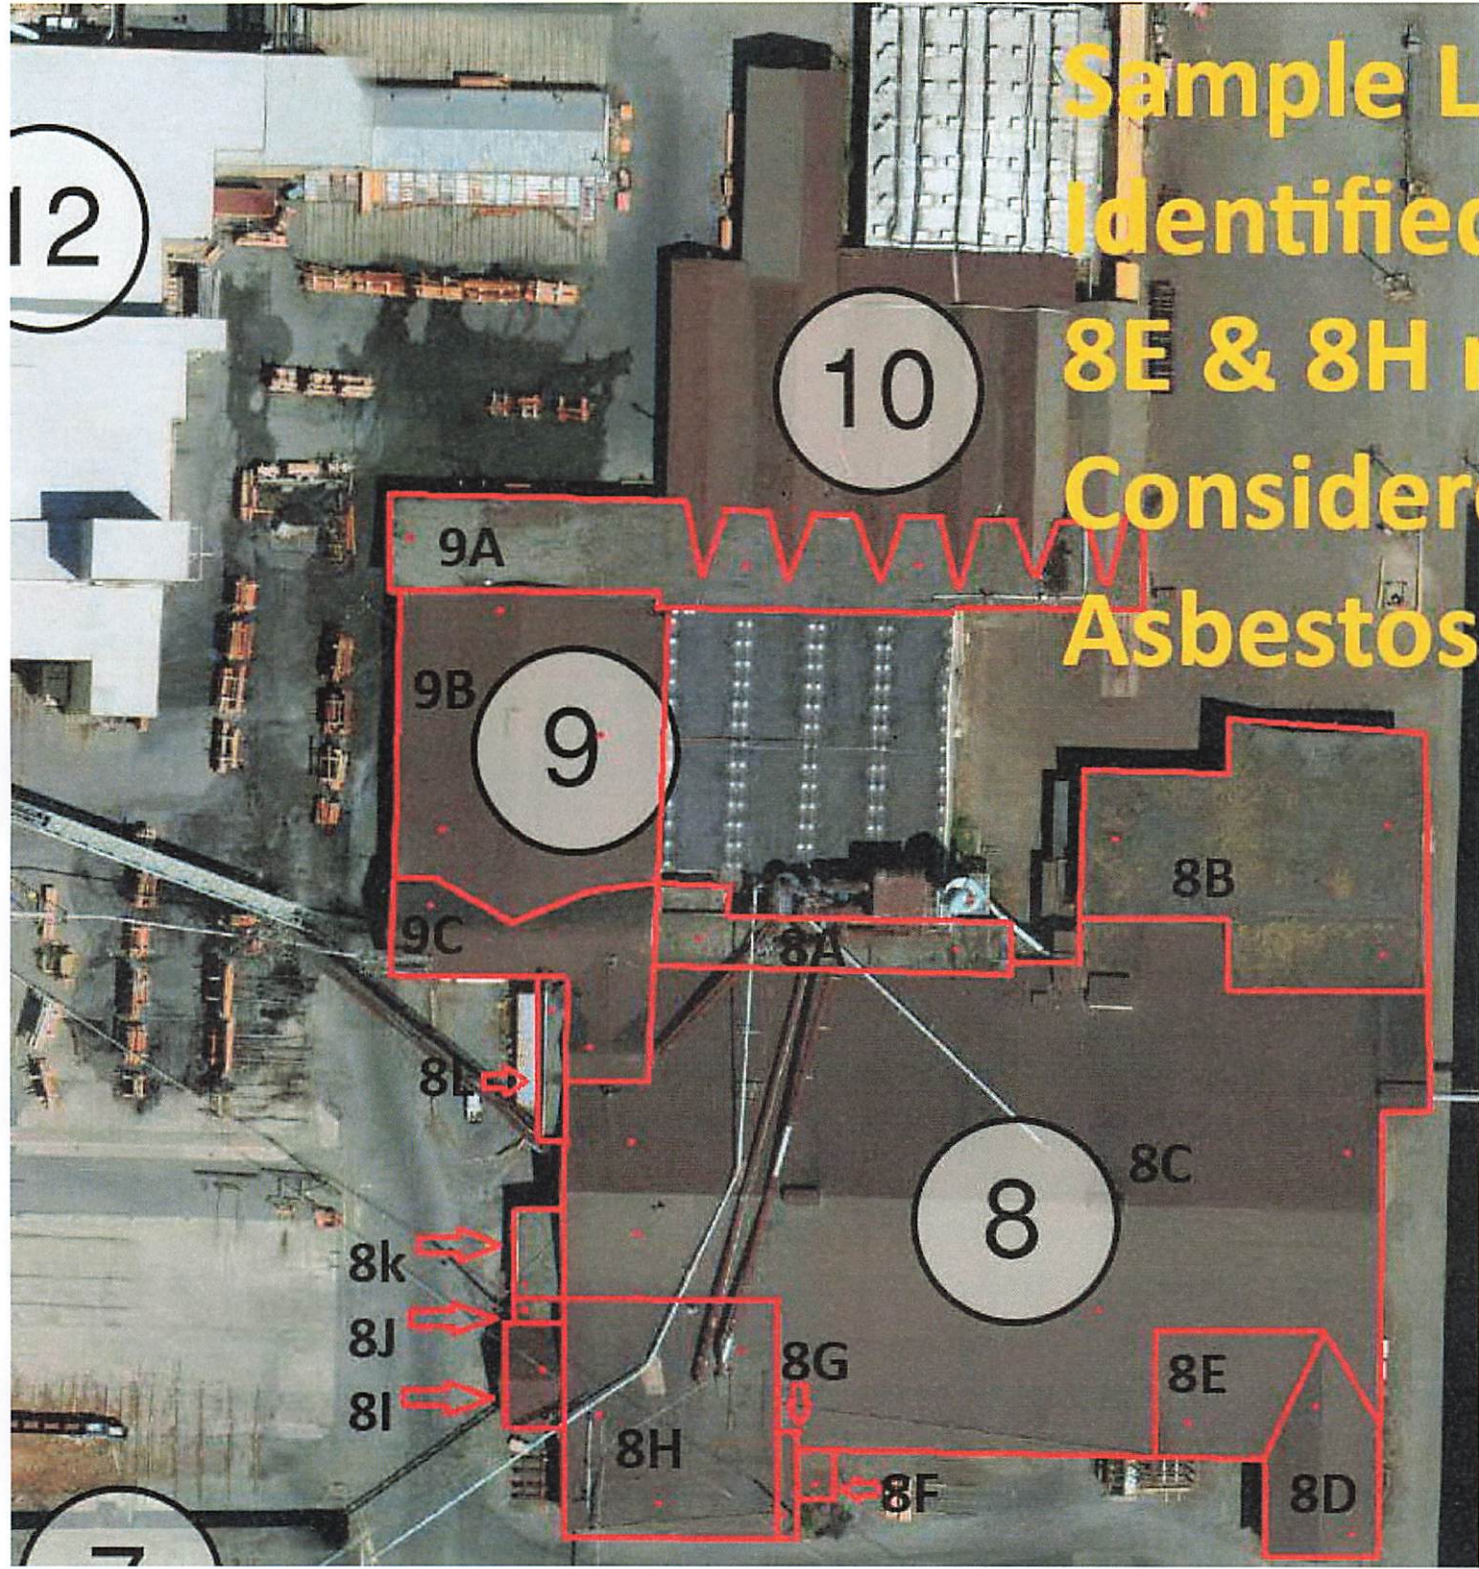
Sample Locations
Identified as 8C, 8D,
8E & 8H must be
Considered
Asbestos-Containing

6.1 Asbestos-Containing Materials: The materials described as Asbestos containing in Section 5.1 must be removed or safely contained by a qualified Asbestos remediation contractor prior to general demolition. 'Moderate Risk' procedures as described in the WorkSafe BC publication Safe Work Practices for Handling Asbestos (BK27), must be followed for removal of roofing. (Occupational safety hazard – Moderate)
