#### STAGE 1 PRELIMINARY SITE INVESTIGATION

McLean Mill 5633 Smith Road, Port Alberni, BC

TerraWest Environmental Inc.

April 18, 2019

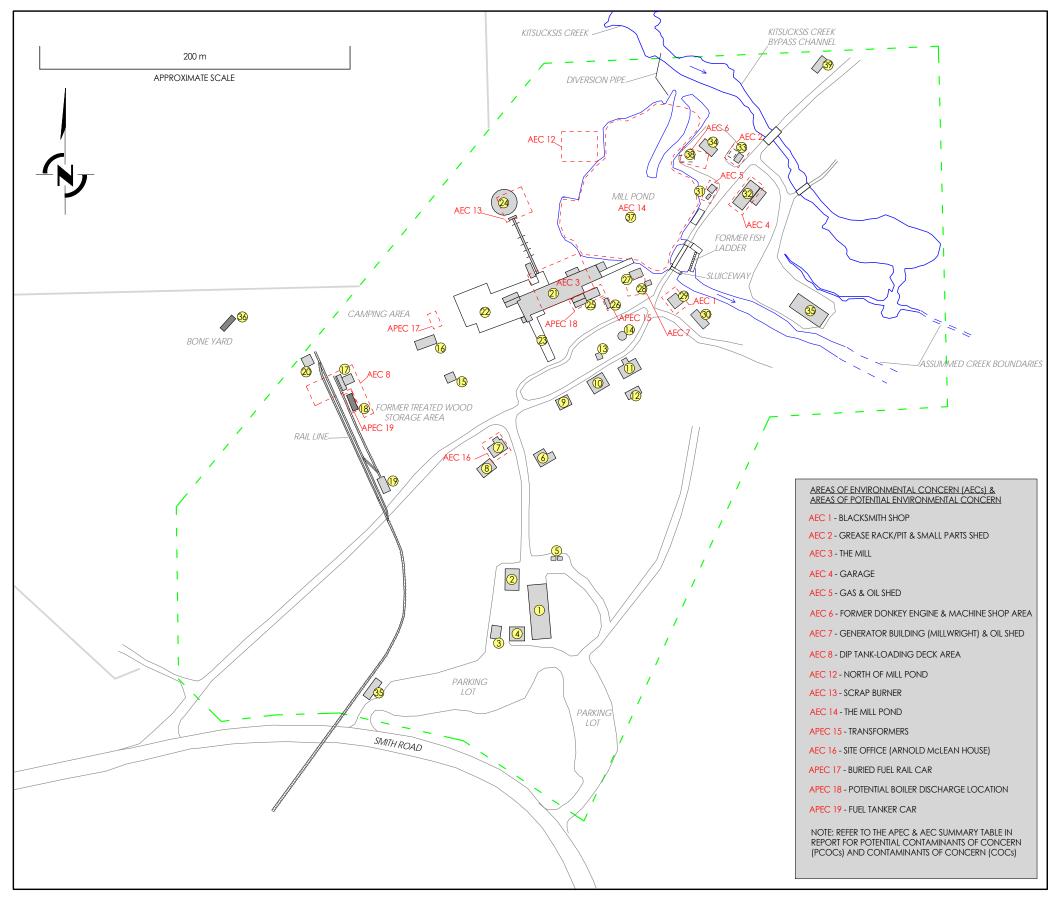
#### FIGURE 6. SITE PLAN - AECs AND APECS

AEC 4 (on-Site)	Garage-32- former service pit, oil staining over garage floor, and abandoned heating oil tank under lean-to. Envirochem 1994, completed soil investigations for metals and MO&G and a limited groundwater investigation for dissolved metals, TEH, BTEX, and Chlorinated Phenols.  Peview of analytical confirmation samples exceeded current applied  Soil COCs - HEPH, sele Groundwater and and maintenance metals, TEH, BTEX, and maintenance metals, LEPH, Here and maintenance metals.		Soil COCs - PAHs, LEPH, HEPH, select metals Groundwater PCOC - PAHs, LEPH, HEPH, select metals Vapour PCOC - VOCs

AEC 8 (on-Site)	Dip Tank/Loading Deck Area-17- surrounding rail spur, loading deck and dip tank. Former location of wood treatment product, former location of oil water separator system and stored barrels with ground staining.  Envirochem 1994, completed soil investigations for metals, MO&G, PAHs, chlorinated phenols and groundwater investigations for metals,	Chemical wood treatment location and petroleum storage and transfer area.	Soil COC and PCOC - PAHs, LEPH, HEPH, select metals, chlorinated phenols Groundwater PCOC - PAHs, LEPH, HEPH, select

APEC 18 (on-Site)	Boiler Discharge Location - Steam boilers used in the operation of the mill between 1927-1965 and again between 2001 and 2018.  It is not known if the former or current functioning boiler is connected to appropriate discharge facilities (BE, TP, JA-pers.comm.). Blowdown discharge has the potential for metals to be discharged with water.	Blowdown discharge containing select metals	Soil PCOC - select metals Groundwater PCOC- select metals
APEC 19 (on-Site)	Fuel Tanker Car-18- Bunker C fuel storage and transfer area from approximately 2001 to 2018 (BE-pers.comm.). Surface staining observed over ground beneath rail car during Site inspection.	Petroleum storage and transfer area	Soil - PAHs, LEPH, HEPH Groundwater - PAHs, LEPH, HEPH Vapour - VOC

TerraWest recommends a Stage 2 PSI to investigate and delineate the soil, vapour, and groundwater in the APECs and AECs listed above and to compare concentrations of PCOCs and COCs, if present, to the applicable standards.

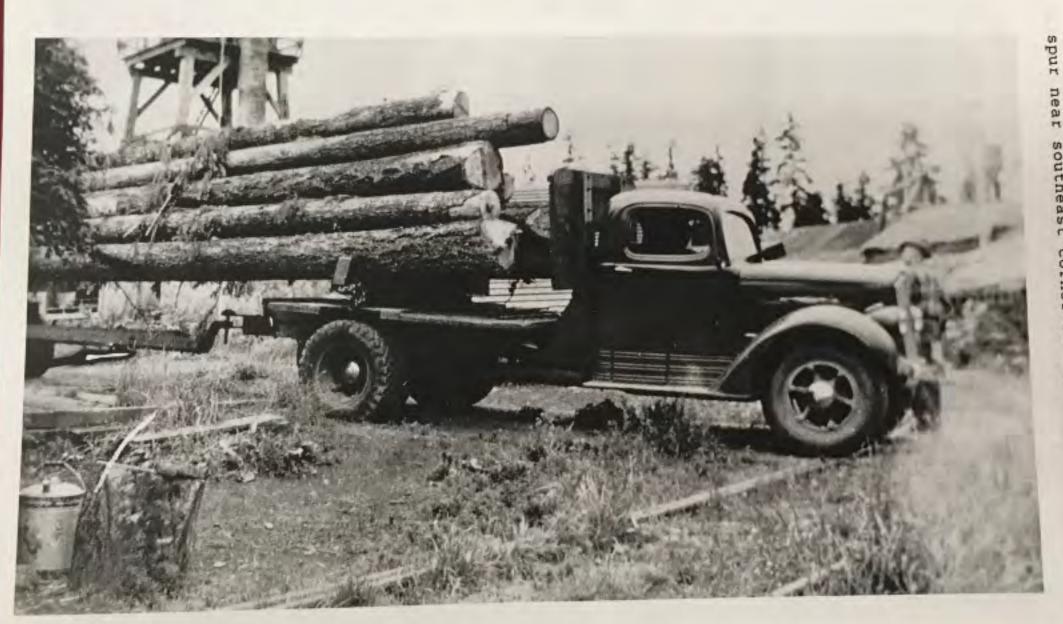
FIGURE 16. 1937 White truck with 1934 Hayes trailer ca. 1937-41. Detail shows plank road crossing railway spur near southeast corner of the mill.

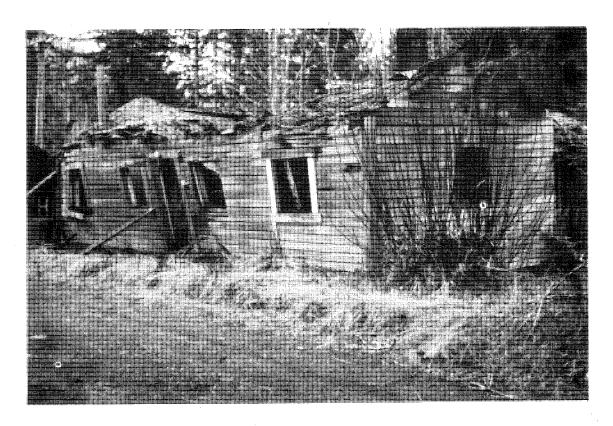
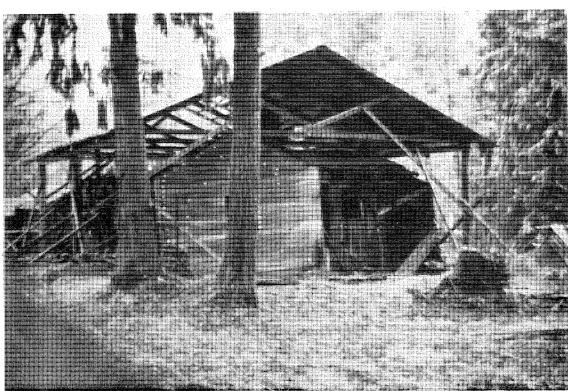
R.B. McLean House (No. 9) in near-collapsed condition, March 1990; and after stabilization and protection by a new roof shelter, July 1992.

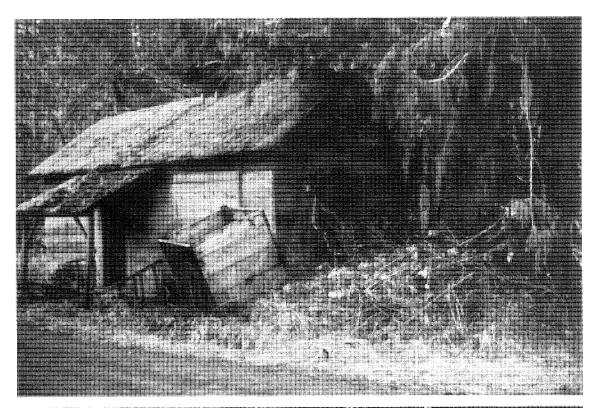
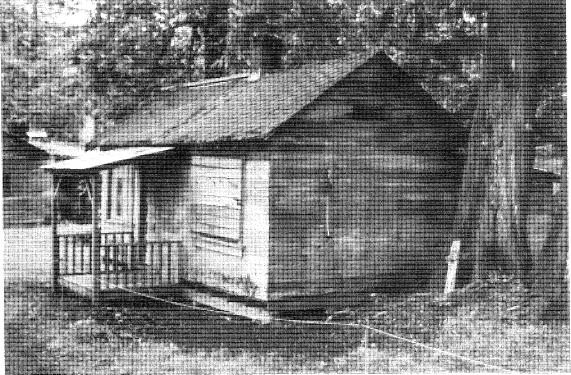
Bookkeeper's House and Office (No. 22) as found, January 1990, and after stabilization, July 1992. Note new sills and floor joists, removal of vegetation around the house, and removal of organic growth from the roof.

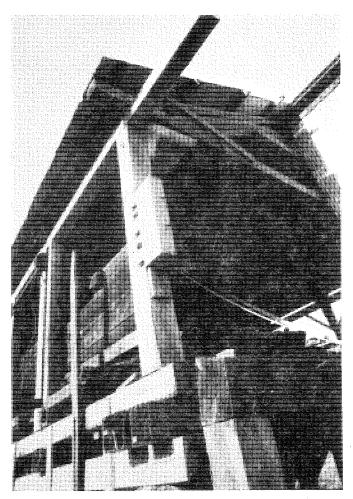
cultural resources. At present the new wood members can be distinguished from the old by colour, but as it weathers it will gradually become indistinguishable. It is therefore recommended that all new members introduced since the initiation of the stabilization process should be stamped (or otherwise marked) with the date of their insertion.

A detail of the mill structure showing new wood components (light) inserted among old components (dark) for stabilization.

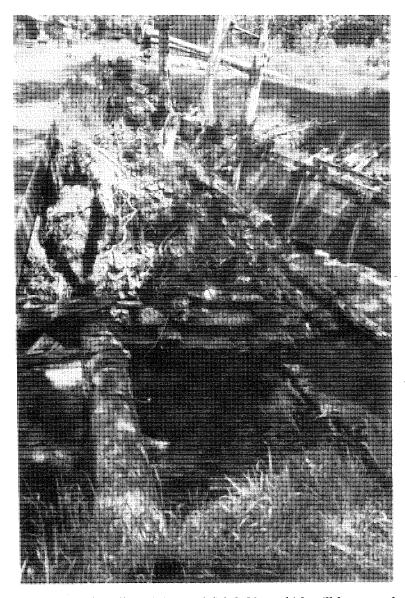
Kitsuksis Creek is a typical coastal stream which is moderately productive for coho salmon and probably for other species as well. The dam and fish ladder which created the mill pond were breached in a flood around 1991, resulting in a new channel for the stream within the old pond area and siltation downstream.

The collapsed dam and fish ladder, which will be restored.

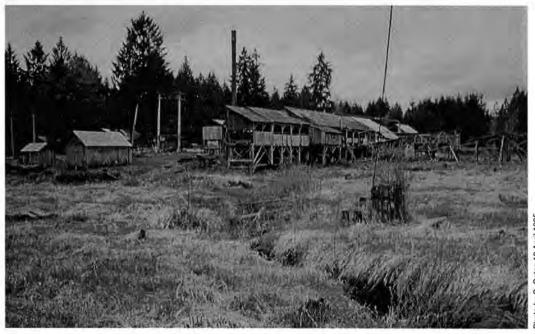
View of the millpond at McLean Mill. Note Kitsuksis creek channel in foreground and mill machinery behind.

A mixture of sawdust, bark, sand, silt, and detritus accumulated in the pond during it use. To provide sufficient depth for millponding, these materials will be excavated to a depth of 0.5-1.5m below the present surface grade. An excavator will load the materials directly into trucks for removal from the site. If stockpiling is necessary, the materials will be placed in a location that prevents siltation of Kitsuksis creek. Since dam failure, Kitsuksis creek has incised a channel approximately 1.5m deep where it traverses the millpond area. Millpond excavation will be the first project component undertaken (see section 1.3 below for complete project schedule).

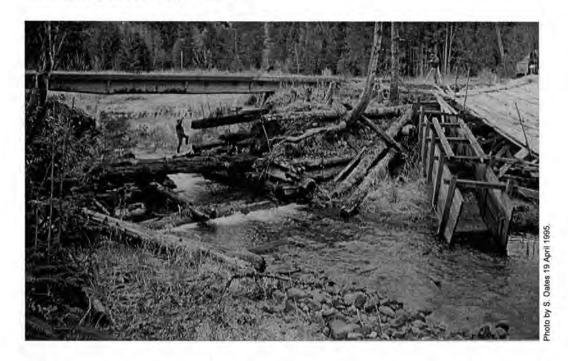
View looking upstream of breach in millpond dam on Kitsuksis creek. The fish ladder in the right portion of the photo will be removed and replaced with a combination spillway and fish ladder.

The breach in the dam will be repaired with a concrete dam, cribwork, and sluiceway. A concrete cut-off wall will be installed on the upstream side of the dam. The remainder of the existing dam structure (wooden crib and earth fill) will remain in place. Concrete dam construction will be tendered and built in two stages from opposite sides of the breach, to ensure that natural flows are maintained in Kitsuksis creek.

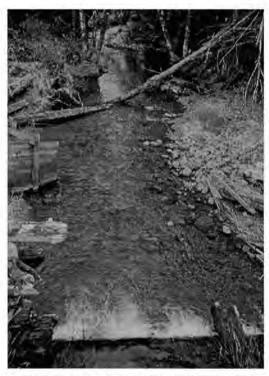
Downstream view of Kitsuksis Creek from breach in dam.

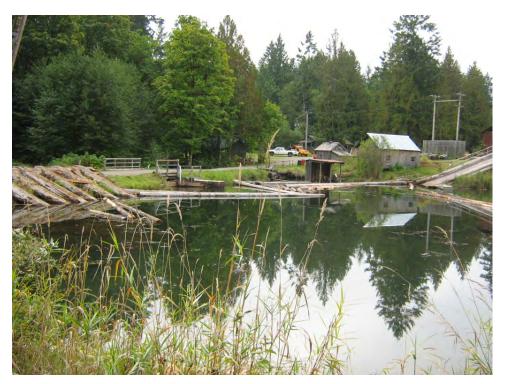
Photo 1. Millpond and dam.

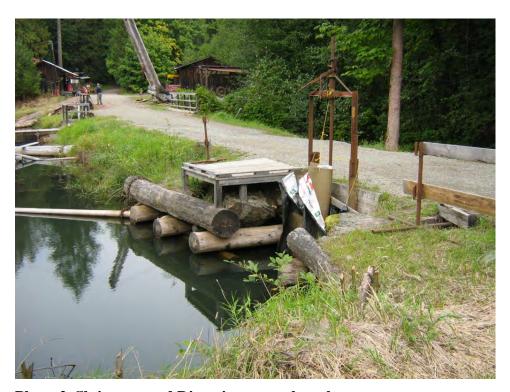
Photo 2. Sluiceway and Diversion control works.

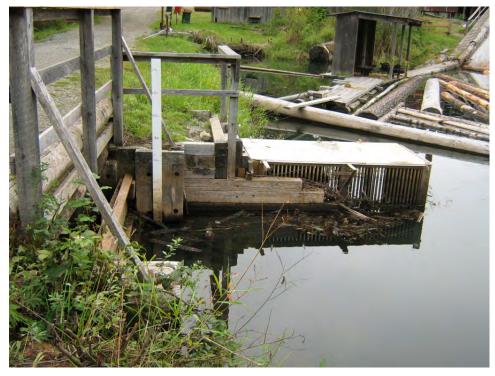
Photo 3. Fishway and Spillway with the fish counter.

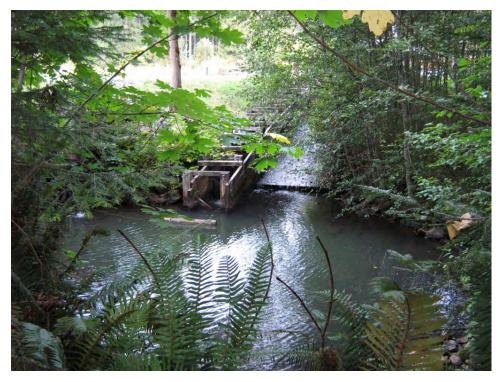
Photo 4. Fishway and Spillway looking upstream from the stilling basin.

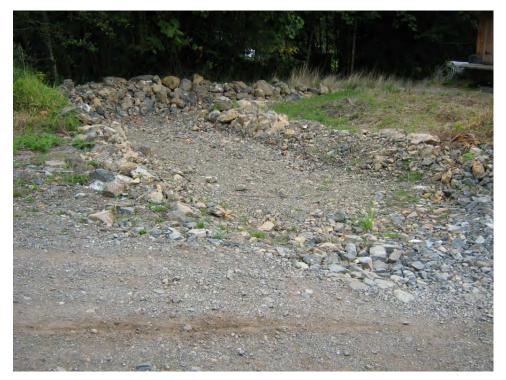
Photo 5. Emergency Spillway.

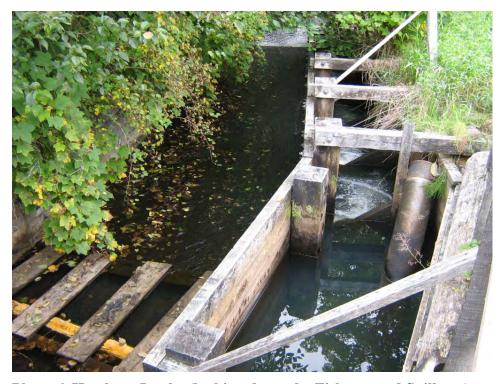
Photo 6. Hatchery Intake (looking down the Fishway and Spillway)

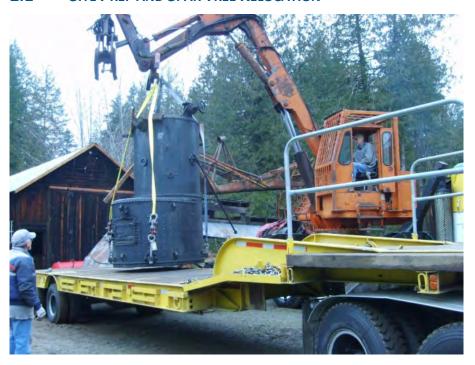
Photo 1. One of the first steps for construction was to relocate some of the heritage equipment. Here a boiler was loaded onto a lowbed using WVIIHS equipment.

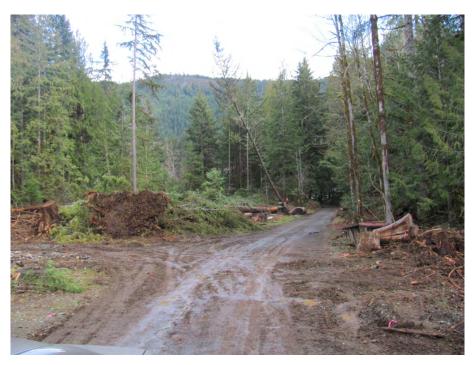
Photo 2. The new spar tree location was 75 m northeast of the bypass channel. Trees at the new setting were felled and bucked, then the stumps were removed, chipped and hauled off the site.

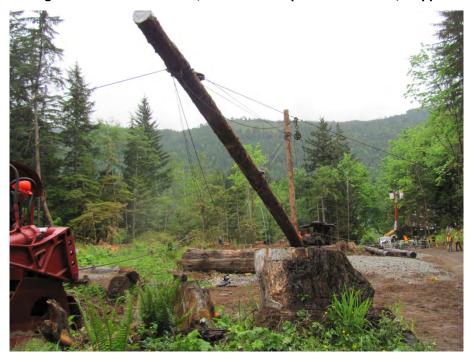
Photo 3. The spar tree was moved, re-rigged and stood up at its new location by JJ Logging and crew (Photo by David Hooper).

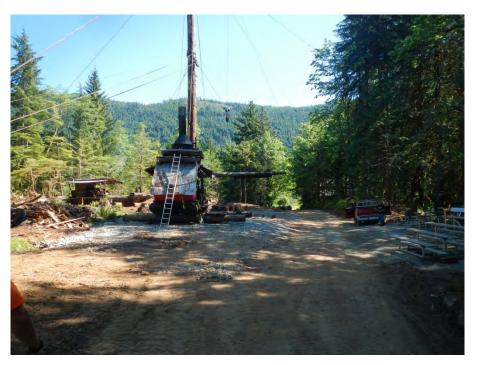
Photo 4. The new spar tree location was completed with a gravel-surfaced work area and spectator seating for the logging show.

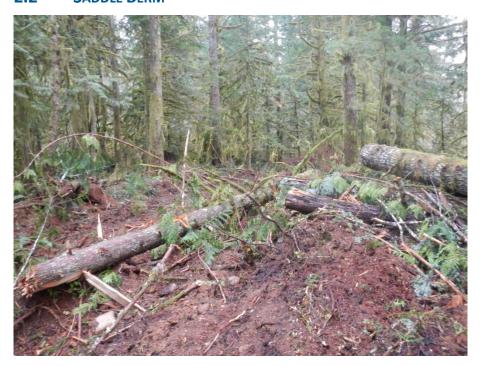
Photo 5. The saddle berm alignment was cleared and grubbed, then the topsoil was removed down to the glacial till surface.

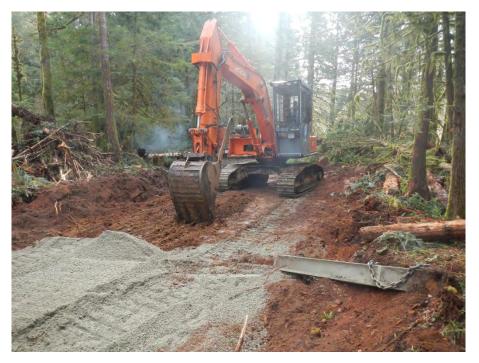
Photo 6. The glacial till was prepared by scarifying the surface, then 25 mm minus crushed rock was used to construct the saddle berm.

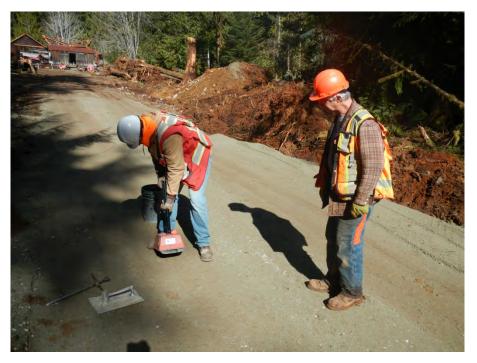
Photo 7. The saddle berm was compacted with a vibratory roller compactor, and then a nuclear densometer was used to test the compaction levels.

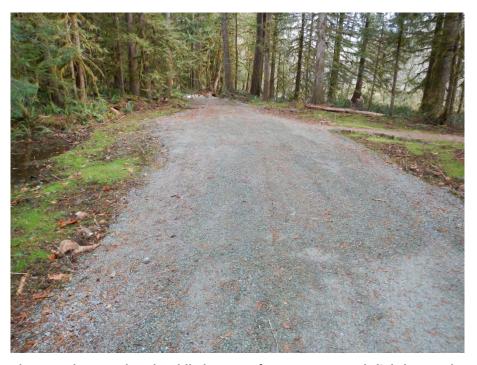
Photo 8. The completed saddle berm surface was crowned slightly to reduce rainfall pooling, and the side areas were smoothed out and vegetated with grass seed.

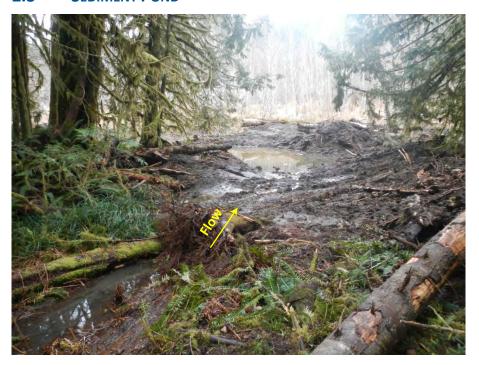
Photo 9. The sediment pond was constructed at the downstream extent of the project (Stn 2+72). Soil from the pond excavation was end-hauled to the spoil area.

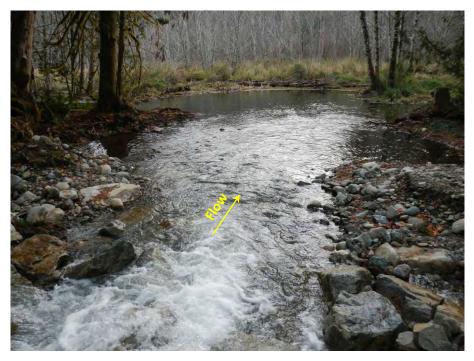
Photo 10. The completed sediment pond dissipates hydraulic energy and helps to settle sediment from the new channel upstream. It provides a good resting pool for fish too.

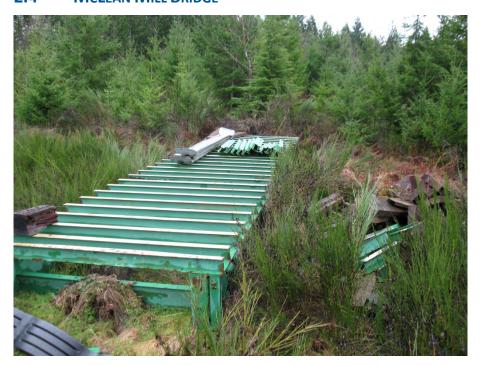
Photo 11. BC Timber Sales donated a steel bridge that was refurbished and installed over the bypass channel.

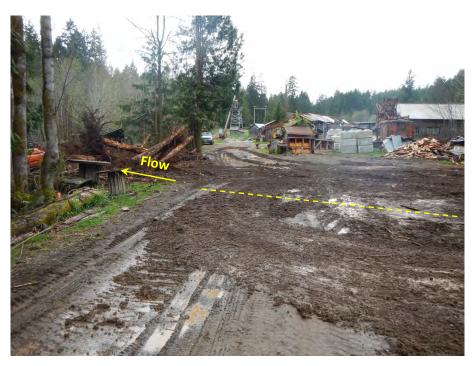
Photo 12. The bypass channel cut through the road to the equipment barn.

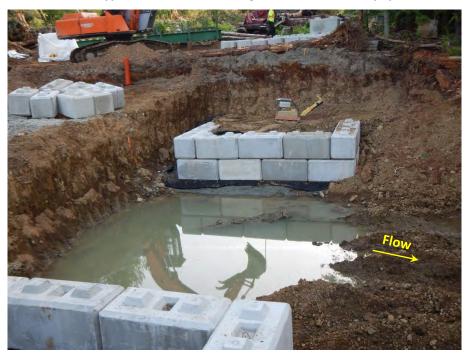
Photo 13. The channel was excavated to the subgrade and the bridge abutments were set using crushed rock, geo-grid, and lock blocks.

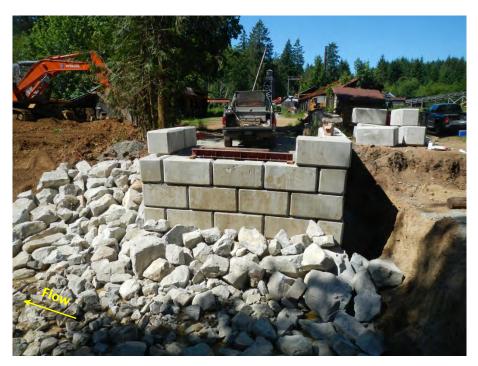
Photo 14. Riprap was placed around the abutment to protect them from scour.

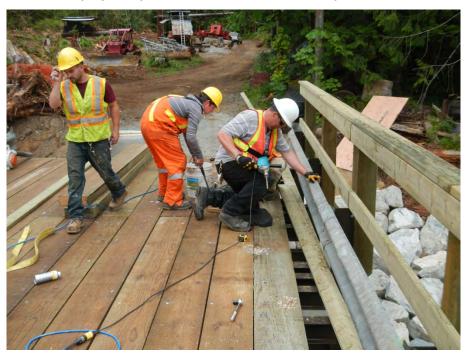
Photo 15. The bridge was widened, sandblasted, and painted. Then City of Port Alberni staff installed the decking, guard rails, and hand rails.

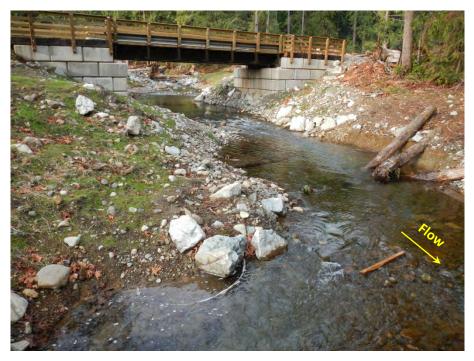
Photo 16. The completed bridge is designed to convey the 200-year flood. Gravel was placed on top of the riprap and the area was vegetated with grass and tree seedlings.

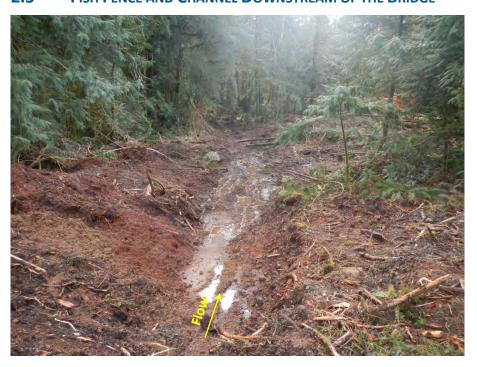
Photo 17. The channel was cleared and grubbed, the photo shows the alignment from Stn 1+30 to 1+70.

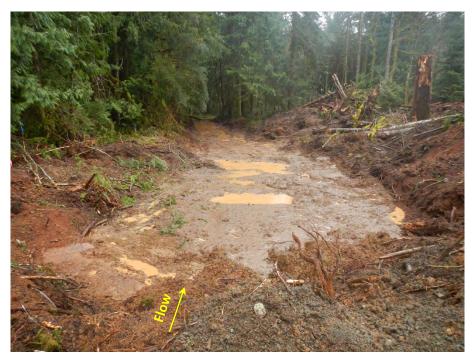
Photo 18. The topsoil was stripped down to the glacial till. The excavated material was end-hauled and stockpiled in the spoil area.

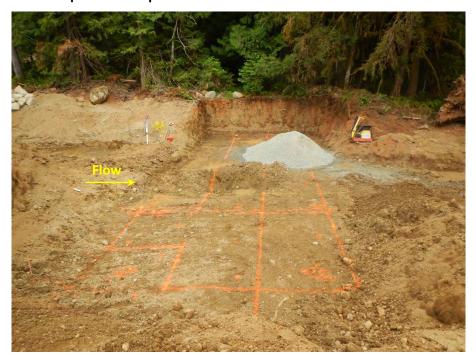
Photo 19. The fish fence was layed out on the ground with marker paint and then a small excavator was used to grade the surface.

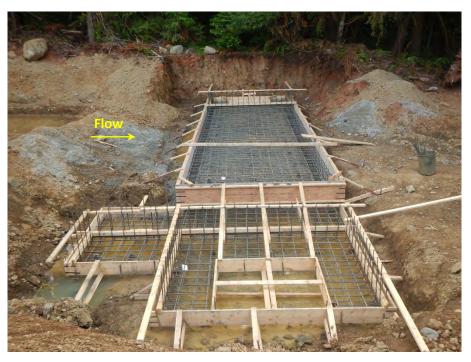
Photo 20. The formwork and reinforcing were installed in preparation for the concrete pour.

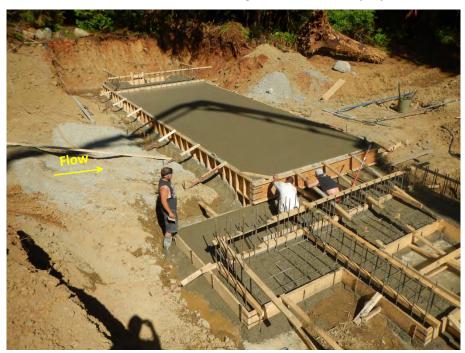
Photo 21. Concrete was poured and finished by Athecon Projects Inc. The concrete cured for a week before it was stripped and backfilled.

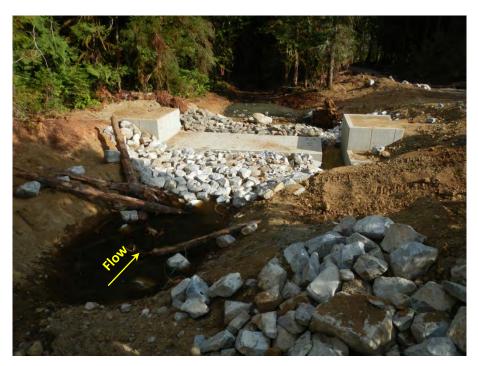
Photo 22. The fishway was backfilled with compacted till, and riprap was placed upstream and downstream of the sill. LWD and spawning gravel were placed in the channel upstream and downstream of fish fence.

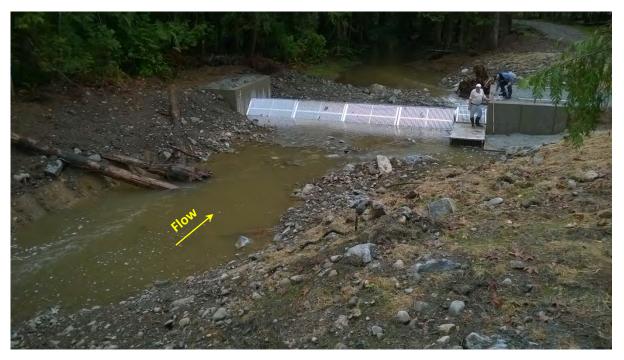
Photo 23. The aluminum fish screens and the old fish trap box were reused.

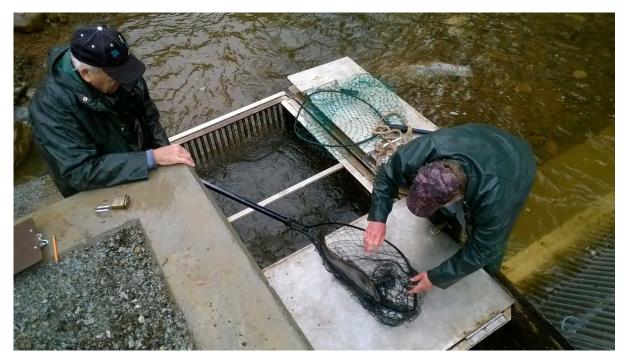
Photo 24. Coho salmon were captured for brood stock and/or enumerated and released at the fish fence by AVES volunteers.

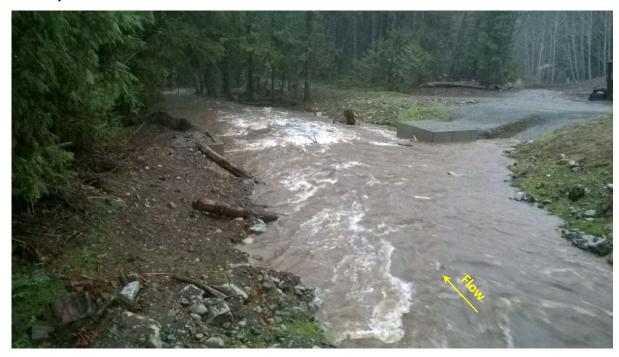
Photo 25. A significant flood on December 10<sup>th</sup>, 2014 tested the project. The fish screens were left in place but were not damaged.

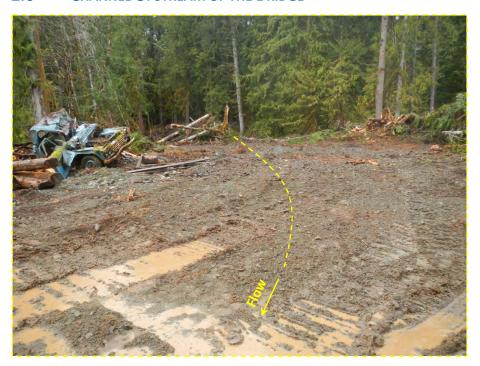
Photo 26. The Heritage Society artifacts and equipment was relocated in preparation of excavating the channel from Stn 0+50 to 0+90.

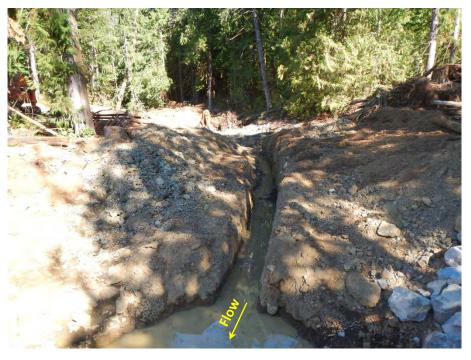
Photo 27. A drainage channel was excavated to drain the upstream area near the intake and the diversion berm.

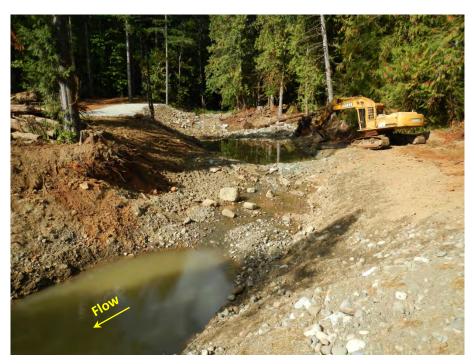
Photo 28. The channel was excavated in the "dry". However groundwater seepage filled up the pools before the creek was diverted. Spawning gravel, habitat boulders, and LWD were placed in the channel to meet the fish habitat objectives.

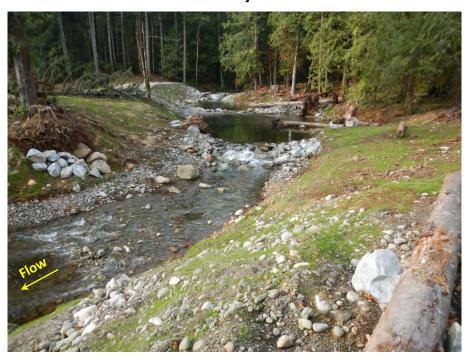
Photo 29. The channel banks were seeded with grass seed to reduce surface erosion, and planted with tree seedlings to help establish a future riparian forest.

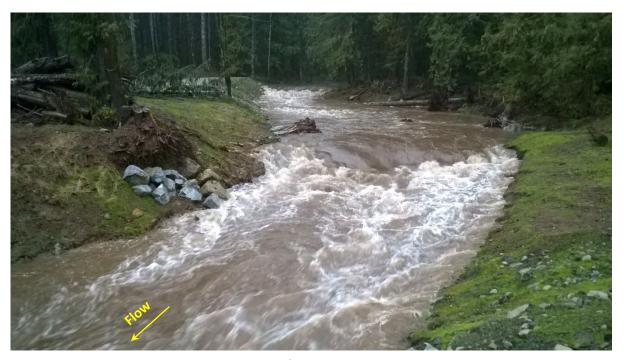
Photo 30. A significant flood on December 10<sup>th</sup>, 2014 caused some minor bank erosion immediately upstream of the bridge near Stn 0+70, but the channel held up well overall.

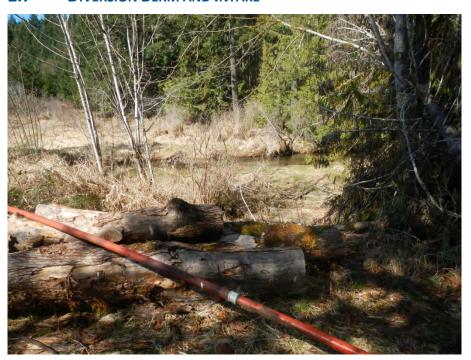
Photo 31. Prior to construction the diversion berm area was vegetated alluvial deposits overlying glacial till.

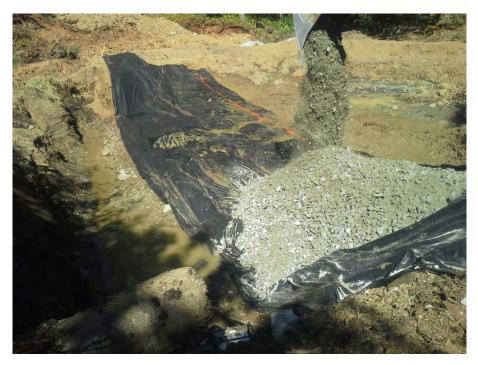
Photo 32. Overburden at the diversion berm area end-hauled to the spoil area. The underlying glacial till was exposed and a rock filter was constructed as part of the structure.

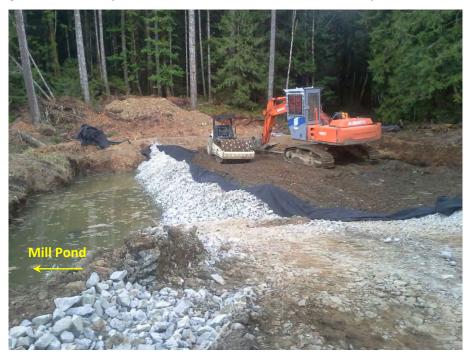
Photo 33. The saddle berm was mainly constructed with compacted till excavated from the new bypass channel.

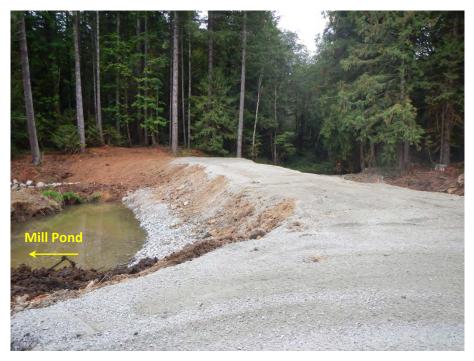
Photo 34. The completed diversion berm had the banks graded at 2:1 slope and the surface covered with 25 mm minus crushed rock with a slight crown to reduce pooling of rain water.

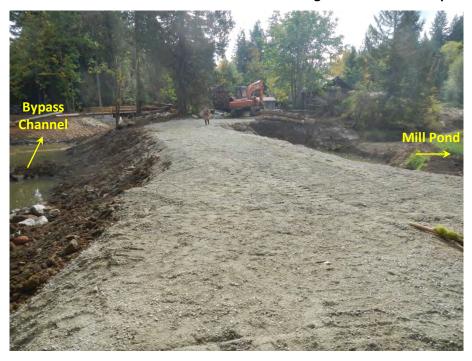
Photo 35. The riprap was keyed into the channel bed and placed up the creek-side slope. The riprap was covered with gravel and vegetated with grass seed.

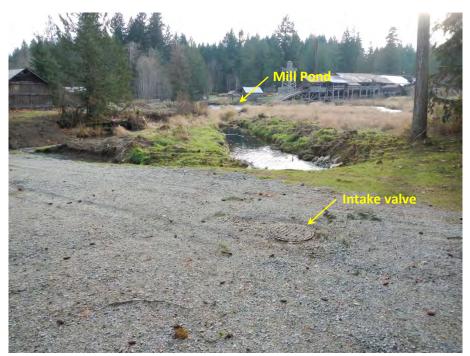
Photo 36. A 300 mm diameter steel and HDPE pipe diverts water from Kitsucksis Creek to the Mill Pond. The diversion flow is controlled by the knife gate valve housed in a concrete manhole.

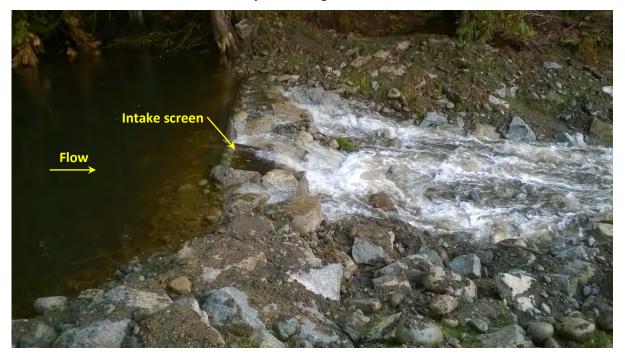
Photo 37. The intake is designed to be mainly self-cleaning, and to facilitate upstream and downstream fish passage. A fine screen keeps fish and coarse sand out of the intake.

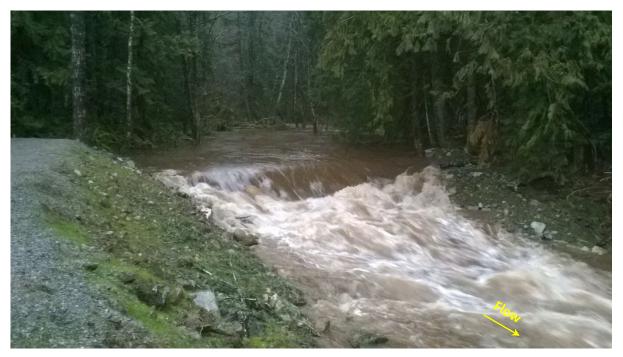
Photo 38. The December 10<sup>th</sup>, 2014 high water event was safely diverted down the new bypass channel. Flow input to the Mill Pond included direct runoff and the intake flow, the Mill Pond water level change during the flood was negligible.

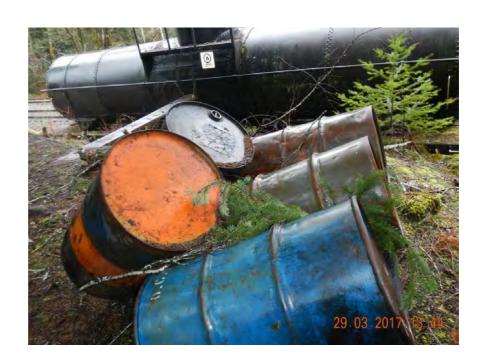
# Photo 2

Foreground barrels under black tarp filled with rail tie plates; tanks in background are an oil/water separating system

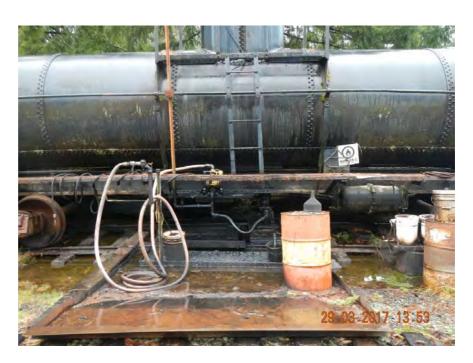
Photo 4

Bunker C fuel car

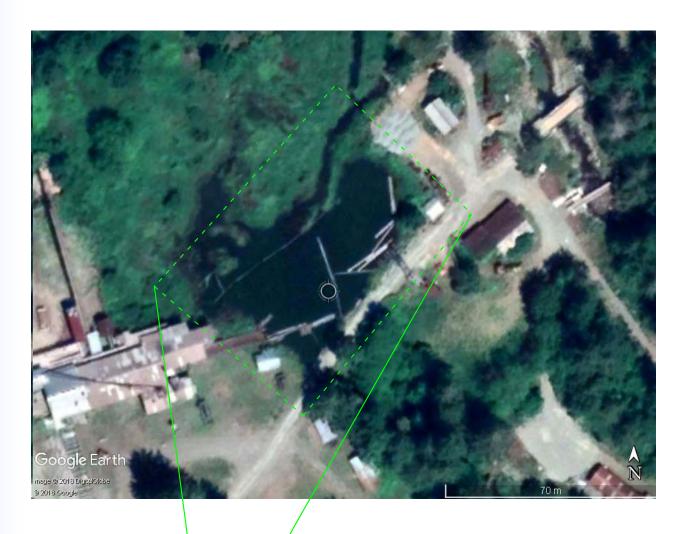
**Photo 6.** Looking east from SS18-03 over mill pond.
